Summary

The following is a summary of the Entergy system performance in areas affected by the weather events on the week of 07/31/23-08/02/23.

StormWatch Weather Event Update for Entergy:

EGSI-East

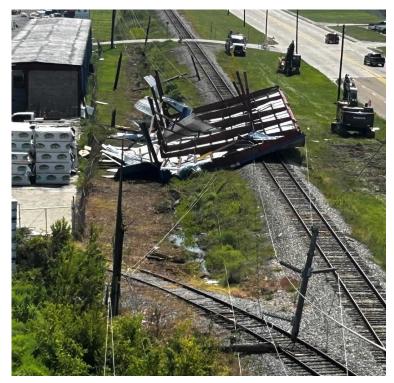
- Two transmission lines sections experienced outages due to wind, lightning, and debris resulting from the storm.
- Until transmission faults were isolated, multiple substations lost their transmission source.
- The Transmission lines were sectionalized, faults isolated and transmission sources to substations restored by 6:45PM on 07/31.
- A limited amount of distribution customers experienced prolonged outage until transmission line structures were rebuilt
- The overall Transmission response took three transmission crews 4 days to restore assets to service.

* Pictured Above - Damaged transmission structures with distribution underbuild

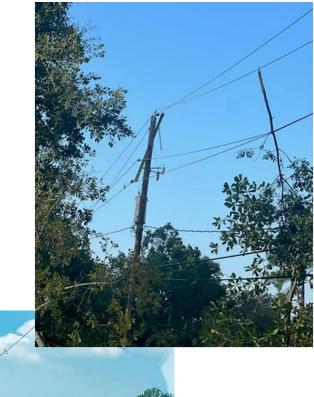
- <u>Accessibility</u> The most hard-hit areas were near W. Tams Drive just northwest of Villa Del Rey Elementary School, Sherwood Forest, and the Broadmoor area. All areas have heavy tree canopy with electric equipment positioned in hard-to-access locations in the backyards of homes. This work can be challenging as it can require specialized equipment and utility workers to climb poles manually to make repairs and restore power.

- <u>Foreign Debris</u> Foreign debris caused by high winds caused damages and extended outages.
- <u>Vegetation</u> trees and tree limbs caused equipment failure and outages.
