Summary

The following is a summary of the Entergy system performance in areas affected by the weather events on the week of 07/31/23-08/02/23.

StormWatch Weather Event Update for Entergy:

EGSI-East

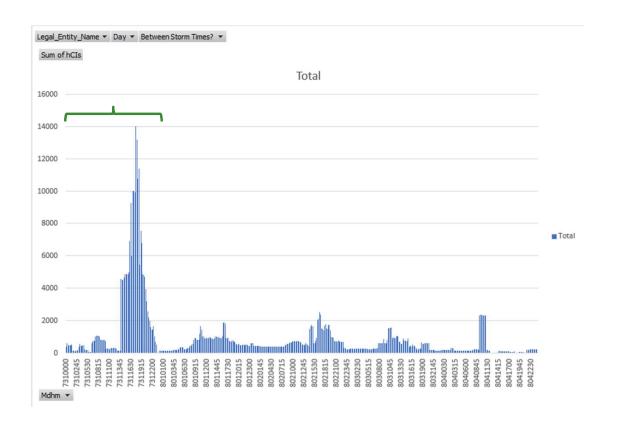
Peak Outage Data

- E-LA Peak Outage total of 14,022 Customers Interrupted at 07/31 around 5:45pm.
- Over 90% of customers restored within approximately 4.5 hours.
- E-LA experienced continuing weather causing additional outages and a second peak of 2,535 Customers Interrupted at 08/02 around 4:45pm.
- Customers were essentially restored by 08/04 around 11:30am.

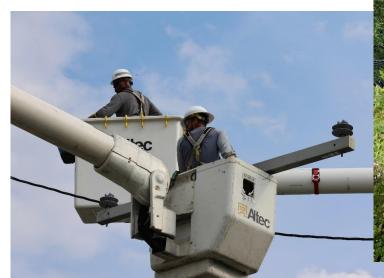
Distribution Line Outages

- Over 200 outages cases contributing 16,177 Cls.
 - 50% of outages cases attributed to Lightning contributing 5,526 Cls
 - 18% of outages cases attributed to Vegetation contributing 3,938 CIs
 - 17% of outages cases attributed to Equipment Failure contributing 4,812 Cls
